west virginia department of environmental remediation
Office of Environmental Remediation

VRP Project #: **15017**
Brownfield Site: Yes ☐ No ☒
Report Date: **6-27-16**
Page **1** of **4**

OFFICE OF ENVIRONMENTAL REMEDIATION
VOLUNTARY REMEDIATION PROJECT
SITE VISIT/INSPECTION REPORT

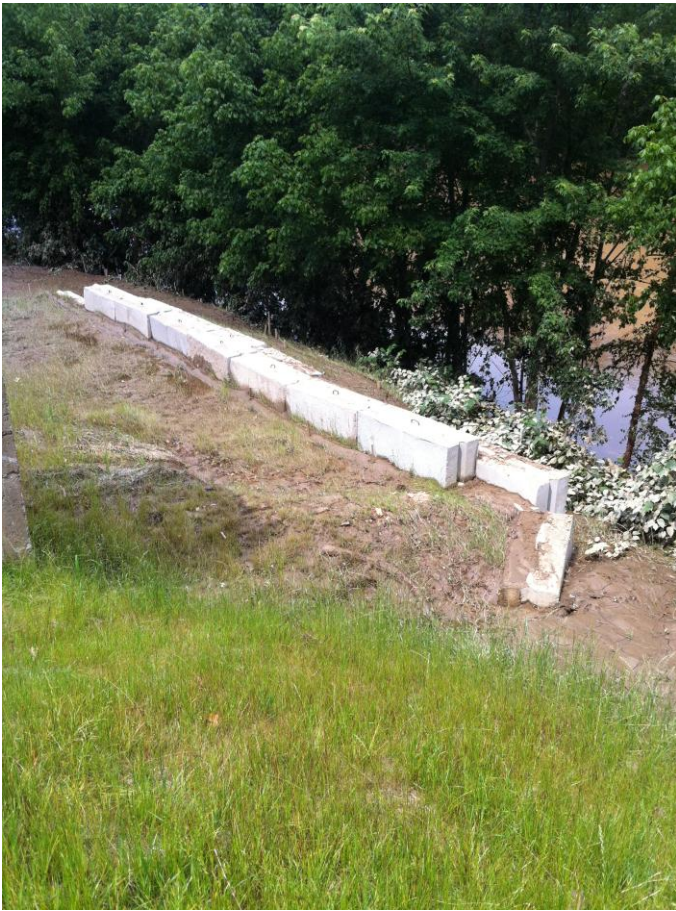
1. Concrete buttress at base of slope.
2. View of concrete buttress and lower road, looking south.
3. Mud and angled blocks at north end of buttress.
4. Bare areas in coconut matting on slope - looking north.
5. Erosion-control boom south of buttress.
6. View of lower road and mud, looking south.
7. View of sparse grass growth in matting - mid-slope area.
8. View of sparse grass growth in matting - upper-slope area.
